ASBESTOS INSPECTION RESULTS

Causeway Blvd. – Earhart Expressway
Route: LA 3046 & LA 3139 (Parcel No. 2-1)
Metairie, Jefferson Parish, Louisiana 70001

SEMS Project #533-0022

Project Name: Causeway Blvd. – Earhart Expressway
Route: LA 3046 & LA 3139 (Parcel No. 2-1)
Metairie, Jefferson Parish, Louisiana 70001
State Project No. H.013842, FAP H013842

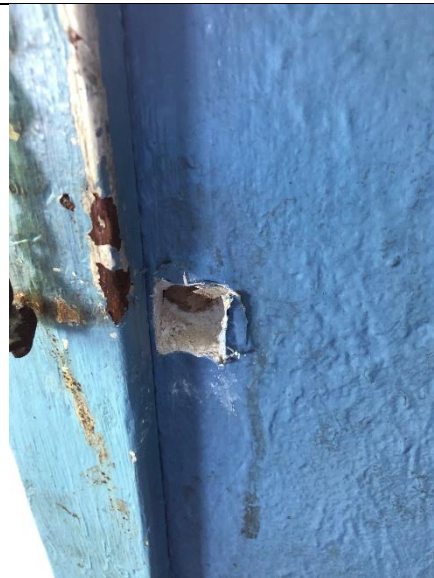
Sample ID	Material Description	Location	Result
AH-20-364-004	Layer 1 - Blue Surfaced Tan Compound	Room 34	2% Chrysotile
AH-20-364-004	Layer 2 - White Drywall with Paper	Room 34	None Detected
AH-20-364-005	Layer 1 - Tan Surfaced White Compound	2 nd Floor Suite	2% Chrysotile
AH-20-364-005	Layer 2 - White Compound Beneath Tape	2 nd Floor Suite	2% Chrysotile
AH-20-364-005	Layer 3 – White Drywall with Paper	2 nd Floor Suite	None Detected
AH-20-364-006	Layer 1 – Tan Surfaced Tan Compound	Room 47	3% Chrysotile
AH-20-364-006	Layer 2 – Green Surfaced Tan Compound	Room 47	3% Chrysotile
AH-20-364-006	Layer 3 – White Drywall with Paper	Room 47	None Detected
AH-20-364-007	Layer 1 – White Surfaced Tan Compound	Room 22	3% Chrysotile
AH-20-364-007	Layer 2 – White Drywall with Paper	Room 22	None Detected
AH-20-364-008	Layer 1 - White Surfaced White Compound	2 nd Floor Stairs	None Detected
AH-20-364-008	Layer 2 - White Compound on Mesh	2 nd Floor Stairs	None Detected

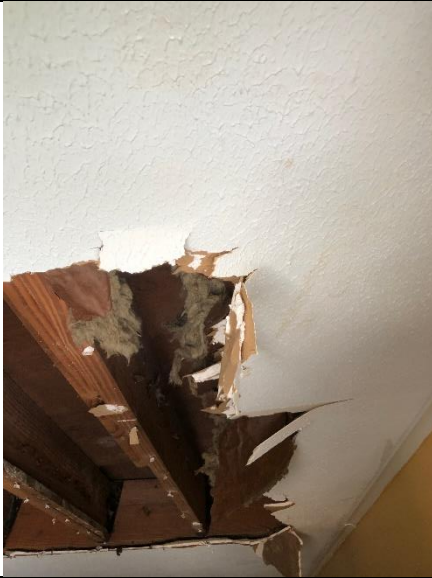
AH-20-364-008	Layer 3 – White Drywall with Paper	2 nd Floor Stairs	None Detected
AH-20-364-009	Layer 1 - White Surfaced White Compound	Room 21	3% Chrysotile
AH-20-364-009	Layer 2 - White Drywall with Paper	Room 21	None Detected
AH-20-364-010	Layer 1 - Tan Floor Tile	Laundry	2% Chrysotile
AH-20-364-010	Layer 2 - Black Mastic	Laundry	5% Chrysotile
AH-20-364-011	Layer 1 - Tan Floor Tile	Laundry	2% Chrysotile
AH-20-364-011	Layer 2 - Black Mastic	Laundry	5% Chrysotile
AH-20-364-012	Layer 1 – Tan Floor Tile	Laundry	None Detected
AH-20-364-012	Layer 2 - Black Mastic	Laundry	5% Chrysotile
AH-20-364-013	Layer 1 - Gray Surfacing	Laundry	None Detected
AH-20-364-013	Layer 2 - Brown Ceiling Tile	Laundry	None Detected

The texture material and joint compound are Category I non-friable asbestos-containing materials. This material will have to be removed by a licensed abatement contractor prior to demolition.

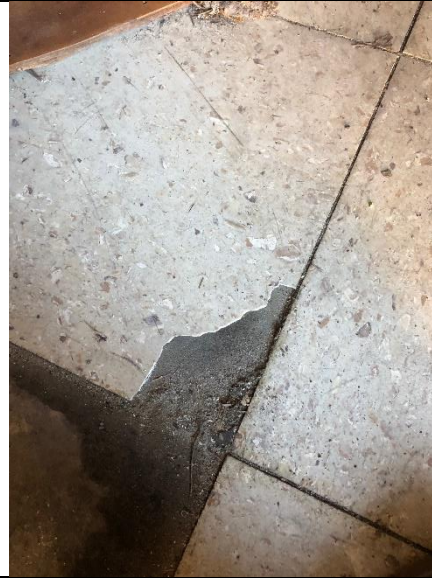
Sample ID	Material Description	Location	Original Result	Point Count Results
AH-20-364-010	Tan Floor Tile	Laundry	2% Chrysotile	2.31%-2.82% Chrysotile
AH-20-364-011	Tan Floor Tile	Laundry	2% Chrysotile	Positive Stop
AH-20-364-019	Tan Floor Tile	Room 29	3% Chrysotile	2.35%-2.87% Chrysotile
AH-20-364-027	Tan Floor Tile	Room 28	3% Chrysotile	3.77%-4.61% Chrysotile

The floor tile and mastic are Category I non-friable asbestos-containing materials. The floor tile and mastic would need to be removed by a licensed abatement contractor prior to demolition.

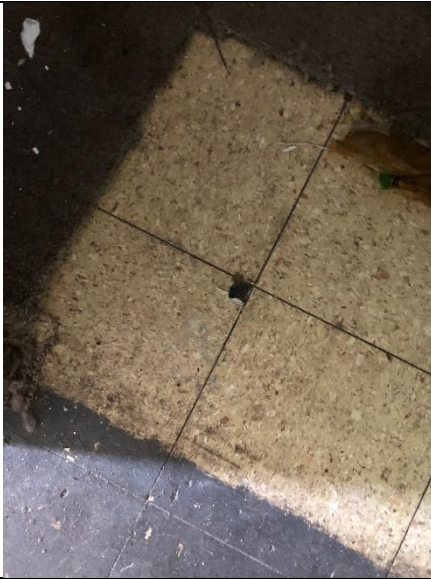
AH-20-364-024	Tan Linoleum	Room 28	None Detected
AH-20-364-025	Layer 1 - Tan Floor Tile	Room 31	None Detected
AH-20-364-025	Layer 2 - Black Mastic	Room 31	5% Chrysotile
AH-20-364-026	Layer 1 - Tan Floor Tile	2 nd Floor Stairs	None Detected
AH-20-364-026	Layer 2 - Black Mastic	2 nd Floor Stairs	5% Chrysotile
AH-20-364-027	Layer 1 - Tan Floor Tile	Room 28	2% Chrysotile
AH-20-364-027	Layer 2 - Black Mastic	Room 28	5% Chrysotile
AH-20-364-028	Green Surfaced White Sealant	Room 6	2% Chrysotile

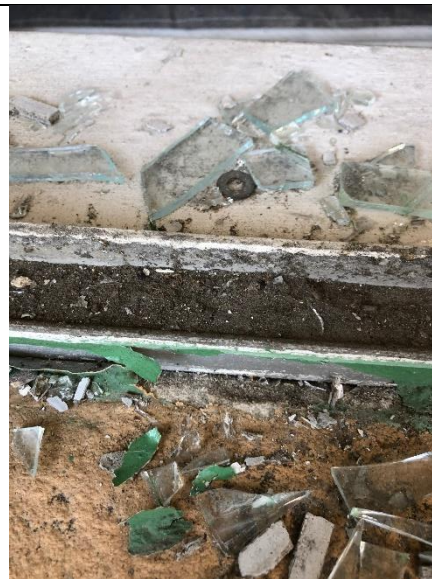
Sample ID	Material Description	Location	Original Result	Point Count Results
AH-20-364-004	Blue Surfaced Tan Compound	Room 34	2% Chrysotile	1.00% Chrysotile
AH-20-364-005	Layer 1 - Tan Surfaced White Compound	2 nd Floor Suite	2% Chrysotile	0.75% Chrysotile
AH-20-364-005	Layer 2 - White Compound Beneath Tape	2 nd Floor Suite	2% Chrysotile	0.75% Chrysotile
AH-20-364-006	Layer 1 - Tan Surfaced Tan Compound	Room 47	3% Chrysotile	1.00% Chrysotile
AH-20-364-006	Layer 2 - Green Surfaced Tan Compound	Room 47	3% Chrysotile	0.75% Chrysotile
AH-20-364-007	White Surfaced Tan Compound	Room 22	3% Chrysotile	1.25% Chrysotile
AH-20-364-010	Black Mastic	Laundry	5% Chrysotile	2.00% Chrysotile
AH-20-364-016	Black Mastic	Room 3	5% Chrysotile	2.25% Chrysotile
AH-20-364-019	Black Mastic	Room 29	5% Chrysotile	1.75% Chrysotile
AH-20-364-025	Black Mastic	Room 31	5% Chrysotile	1.50% Chrysotile
AH-20-364-028	Green Surfaced White Sealant	Room 6	2% Chrysotile	0.25% Chrysotile

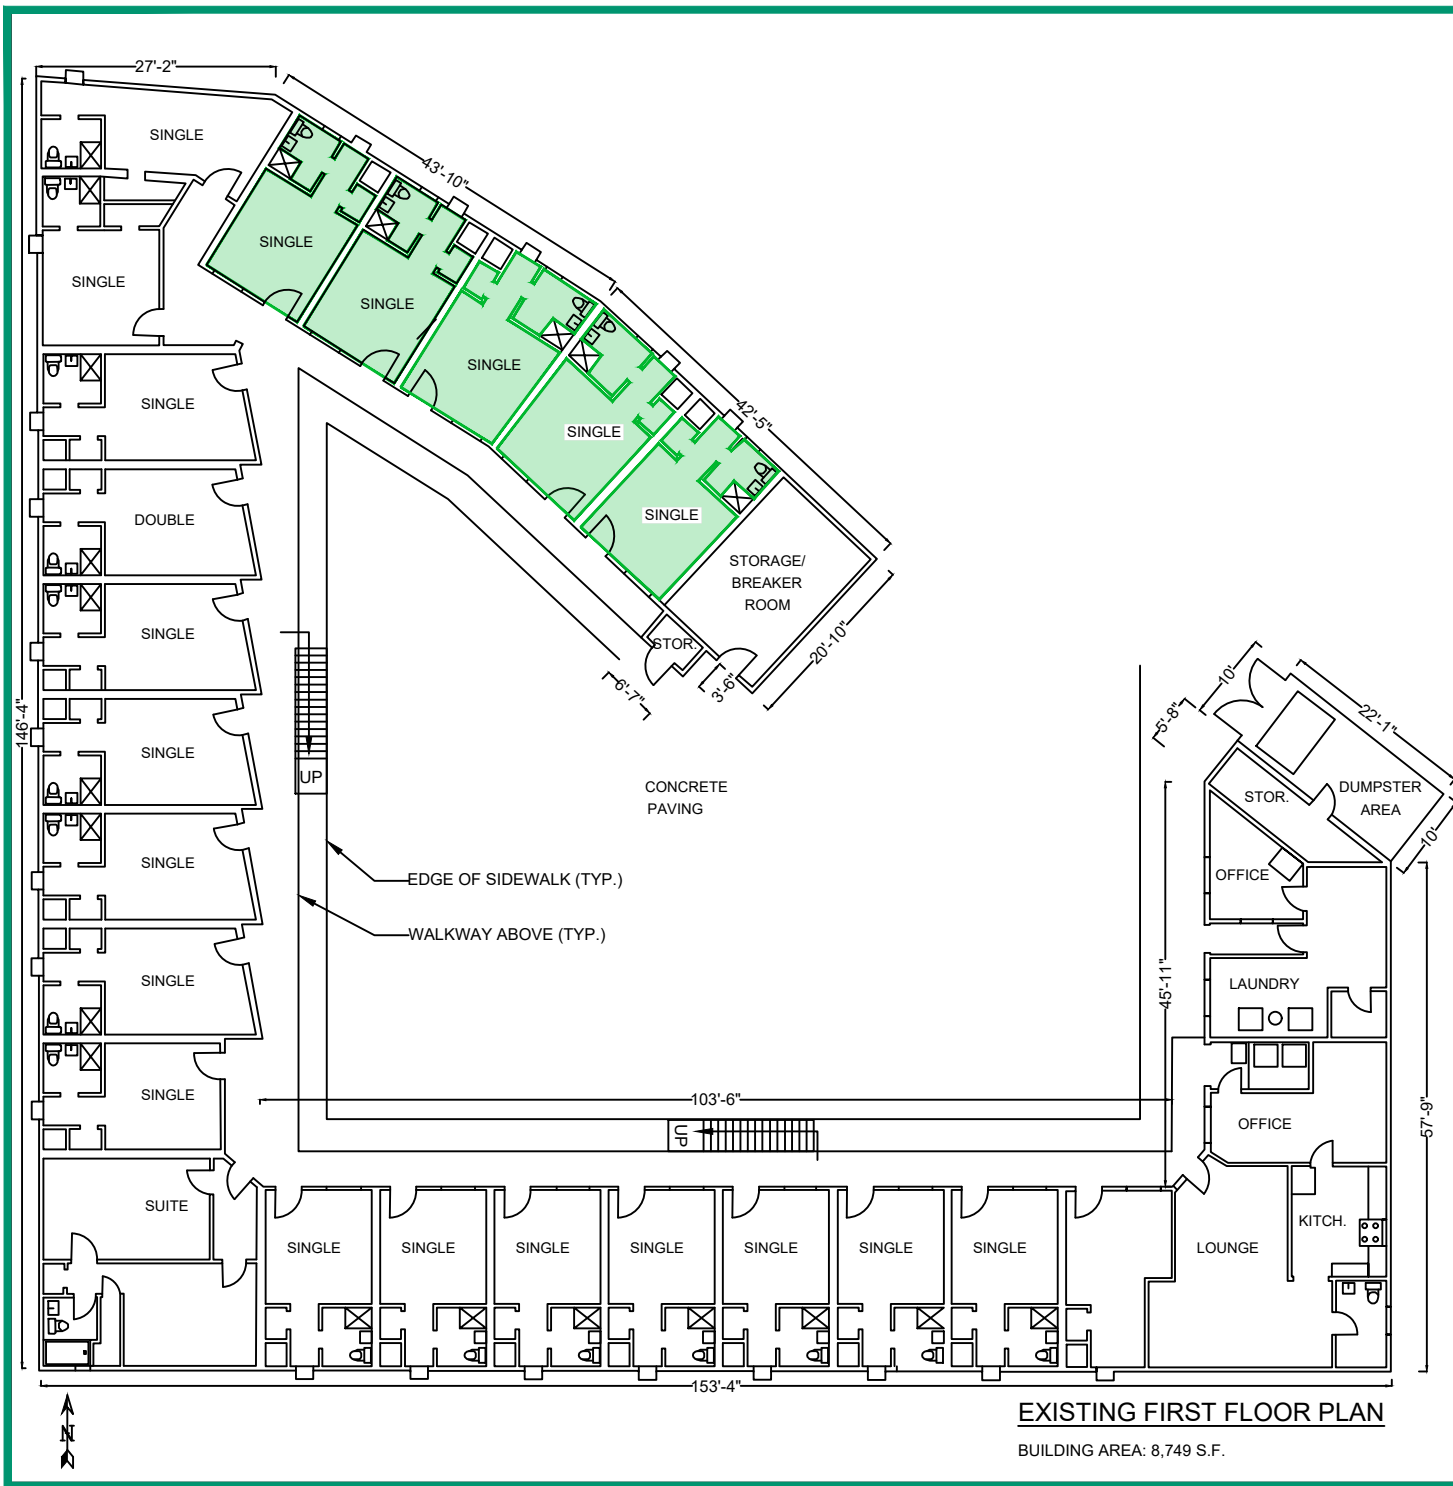
TO BE ABATED (First Floor - Miscellaneous)

- Drywall
- Drywall Ceilings
